BROTHER® HL-5200 SERIES TN550 • 580 TONER CARTRIDGE REMANUFACTURING INSTRUCTIONS

REMANUFACTURING THE BROTHER HL-5200 SERIES TN550/TN580 TONER CARTRIDGES (TN3145/TN3185 EUROPE)

By Mike Josiah and the Technical Staff at UniNet

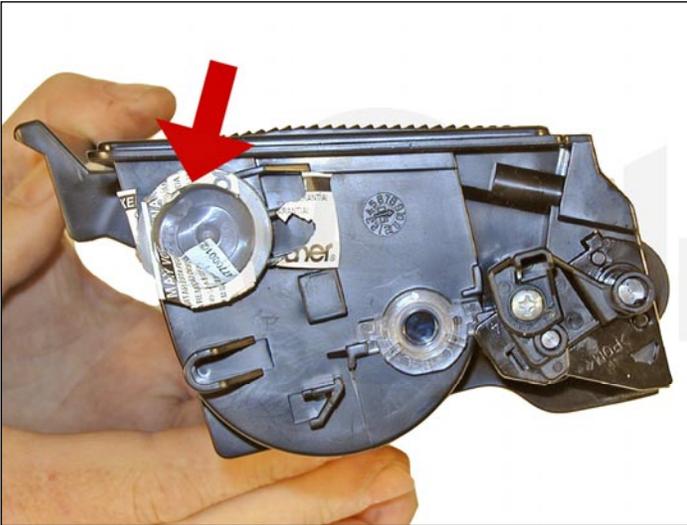
1. Vacuum the exterior of the cartridge. Remove the fill plug from the toner cartridge. Dump the remaining toner and vacuum/blow out the cartridge. Make sure that the gear area is clean. Leaving any toner in the teeth of the gears may cause a tooth to be damaged and cause a clicking noise. We have found it best to use compressed air to clean them out, but to also keep one hand over the gears to protect them.

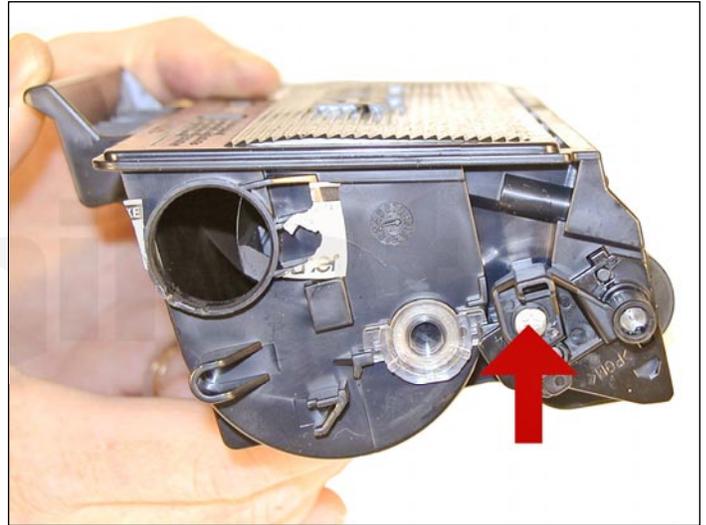
2. On the non-gear side of the developer roller, remove the screw.

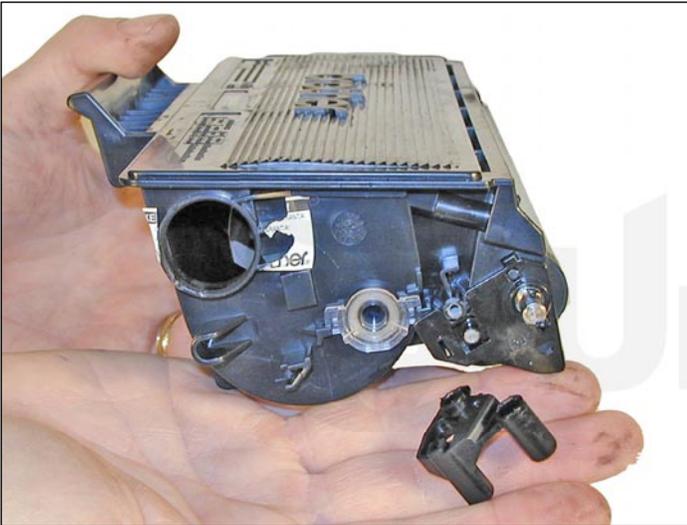
3. Remove the drum axle plate.

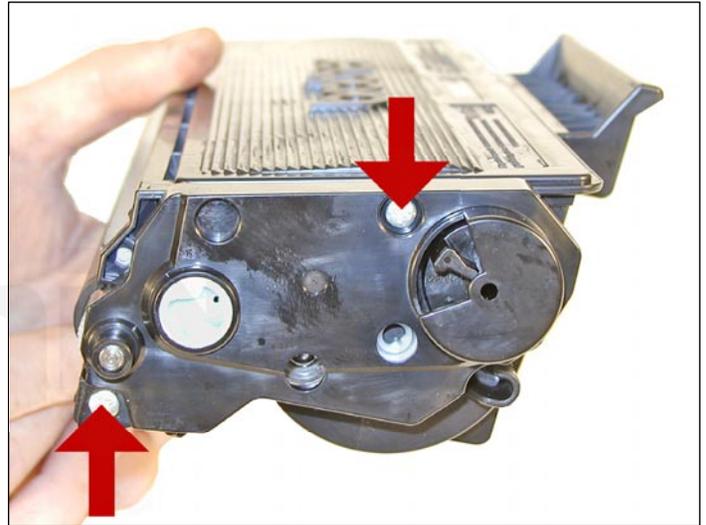
4. On the gear side, remove the two screws and cover plate.

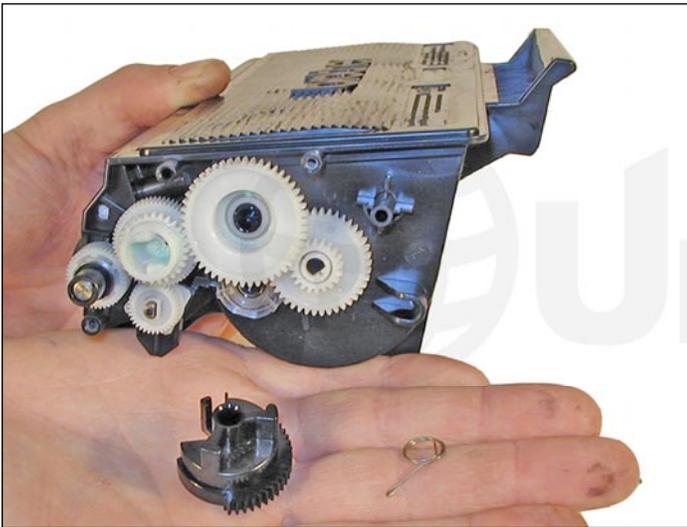
5. The black spring-loaded reset gear may fall off as the plate is removed. This gear resets the printer when the cartridge is installed. New starter cartridges do not have this reset gear. Until they are available, the starter cartridges cannot be remanufactured.

Similar to the TN350, there is a reset gear that resets the printer. The TN550 reset gear is different from the TN350 though. Like the TN350, the starter cartridges that come with new printers do not have this gear. There are actually two different reset gears for TN550/580 cartridges, one for the low yield (550) that has one reset rib, and another for the high yield (580) that has two reset ribs. These gears work by the gear train turning the reset gear and the ribs(s) of the gear press against a new toner actuator bar in the machine. If one rib engages the actuator, it is sensed as a low yield cartridge, if two ribs engage the actuator, it is sensed as a high yield cartridge. New reset gears are available.

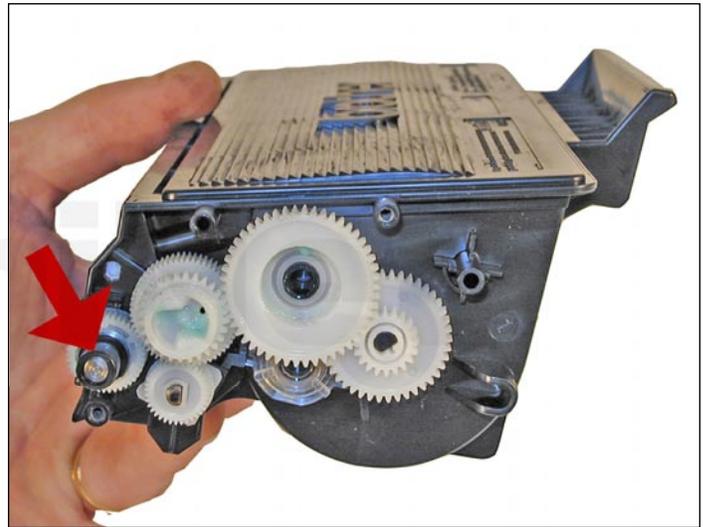
6. Remove the black plastic spacer from the developer roller shaft.

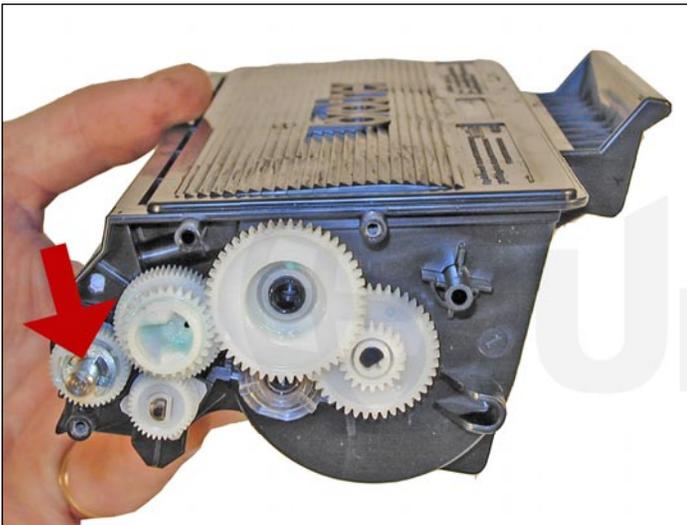
7. Remove the E-Ring, and small gear.

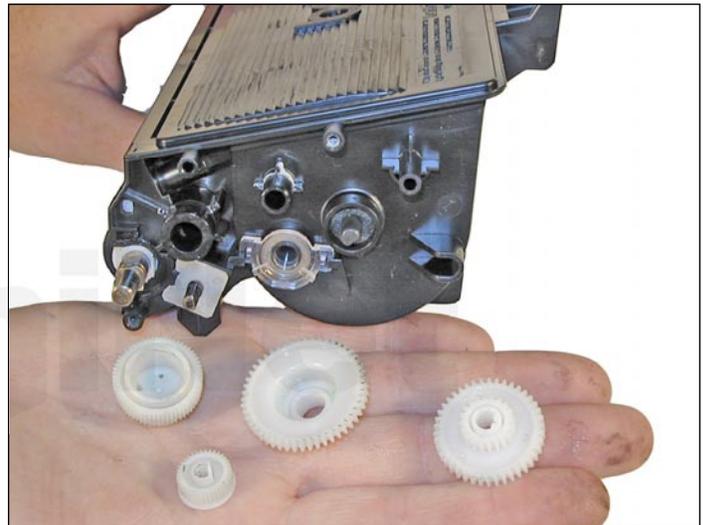
8. Remove all the remaining gears.

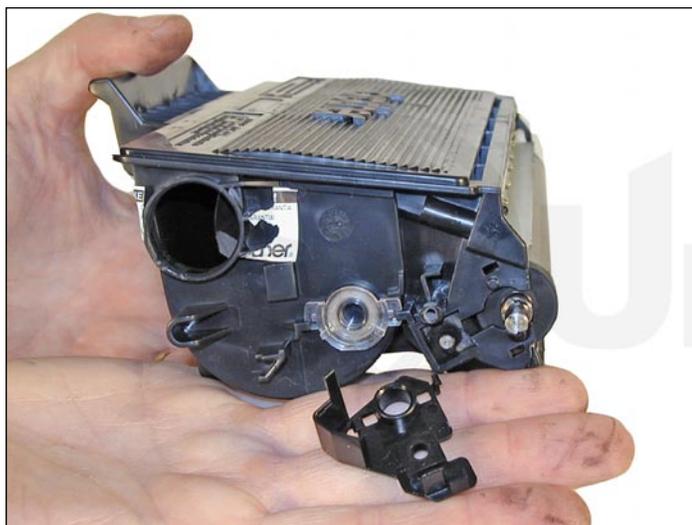
9. Remove the non-gear side end cap by gently prying it off.

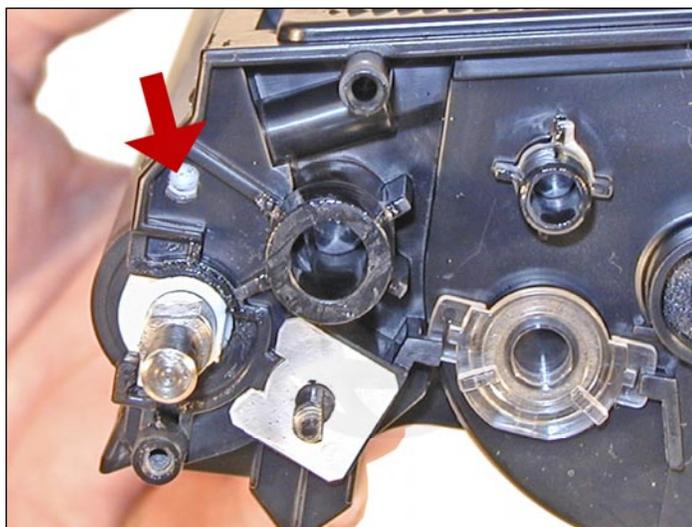
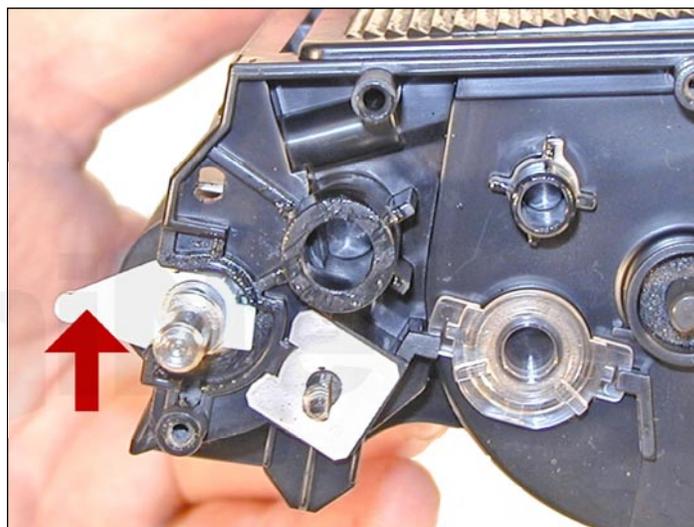
10. On the gear side of the developer roller, press in on the locking tab and rotate the developer roller lock up.

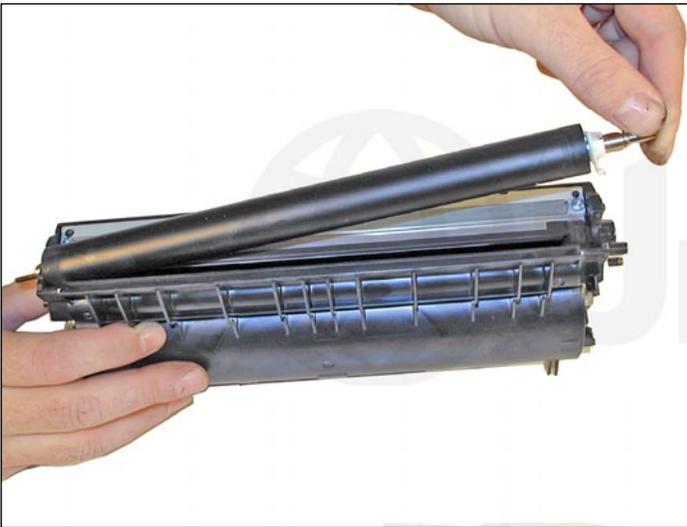
11. Remove the developer roller.

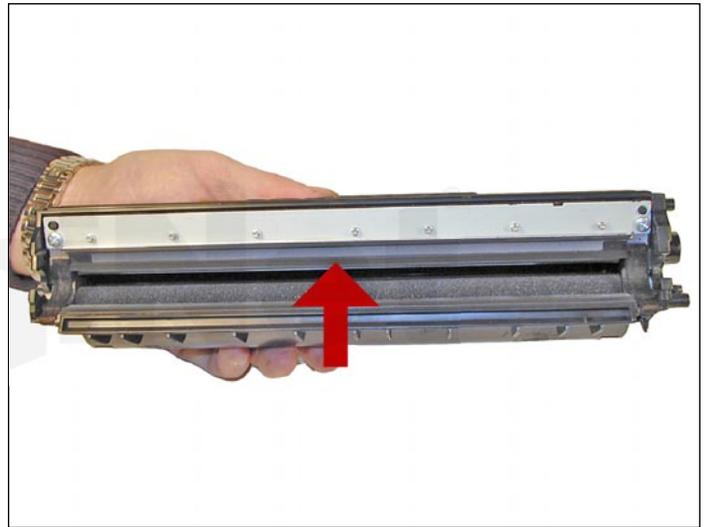
12. Vacuum the doctor blade and foam feed roller clean. We do not recommend that the doctor blade be removed and the developer roller felt seals will be disturbed. Once a new blade is available, great care will have to be taken not to tear the seals, causing a leak. The doctor blade can be easily cleaned by blowing the excess toner off, and wiping down with a lint free cloth. Be very careful not to leave any lint behind!

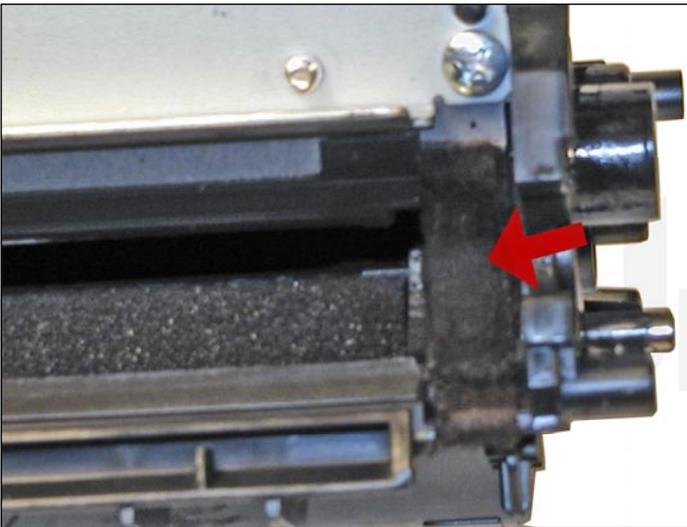
13. Inspect the magnetic roller felts. If they are compressed (shiny), roughen them up with a small screwdriver.

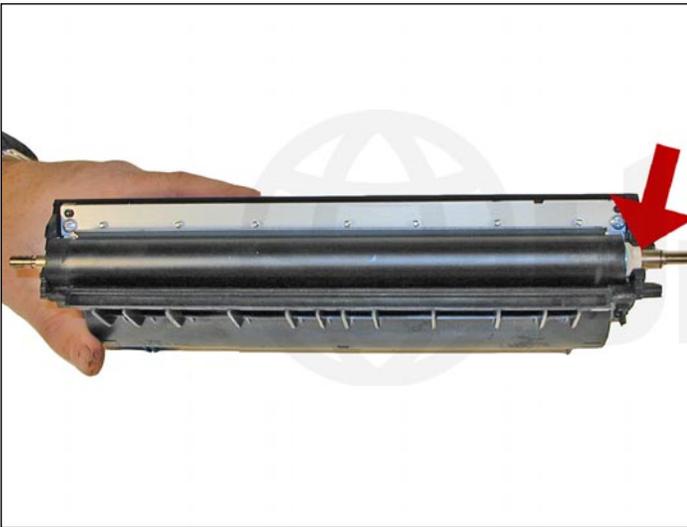
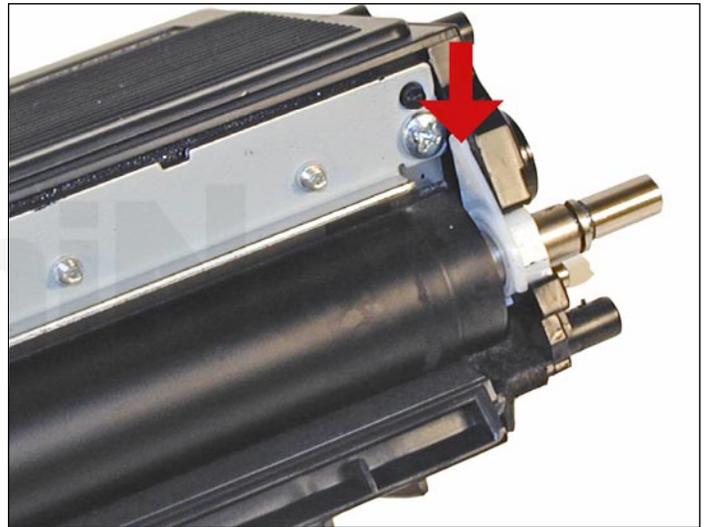
14. Clean the developer roller with a lint free cloth. Do not use any chemicals other than a dedicated cleaner for the Brother rollers to clean the roller. A dry clean cloth will work fine. Re-install the developer roller long shaft side to the gear side, and white lock pointing up. Turn the lock towards the doctor blade until it locks in place.

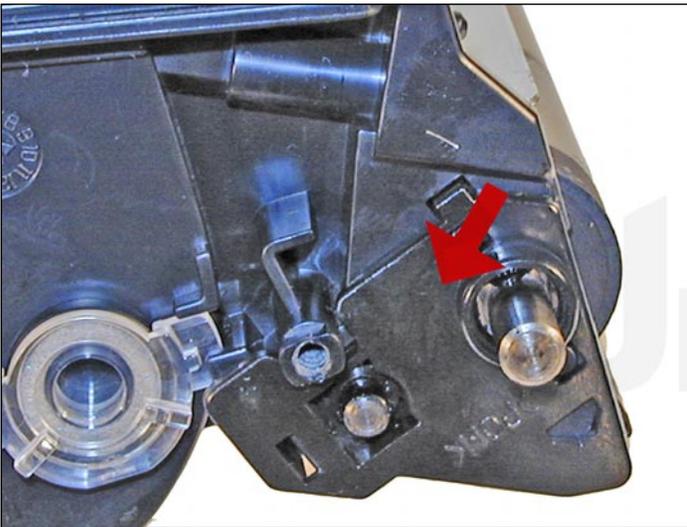
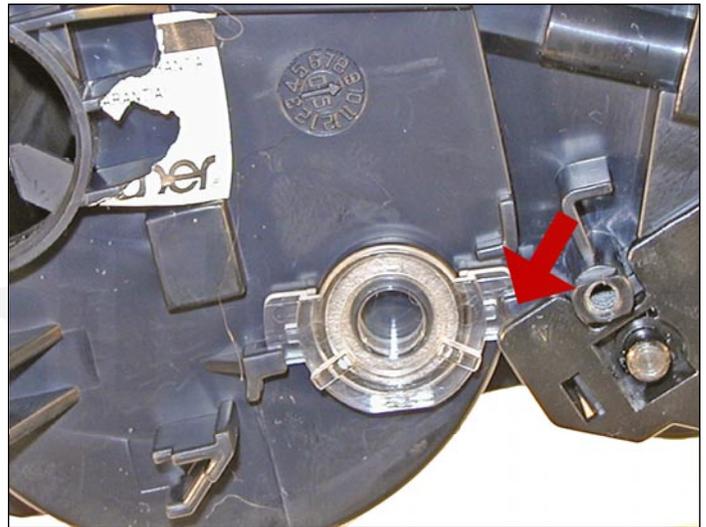
15. Install the small outside end plate on the non-gear side.

Make sure the clear plastic plug for the optical sensor is locked in the proper position.

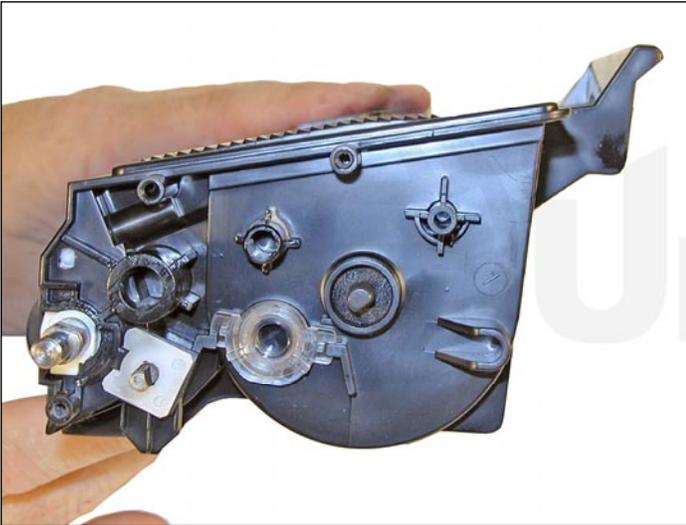
16. Clean the gears, making sure that they have no toner on them. This is a good time to also check the gear shafts to make sure there is enough grease. If the shafts appear dry, or the grease is contaminated with toner, clean the shaft and inside of the gear. Replace the grease with white lithium grease.

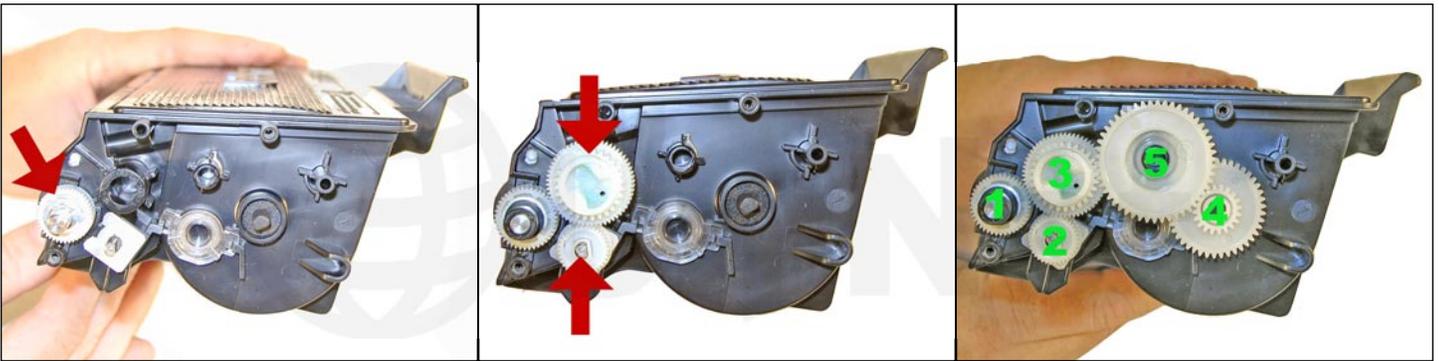
17. Install the developer roller gear, c-ring, black axle and the rest of the gears.

Make sure all the gears are meshing properly.

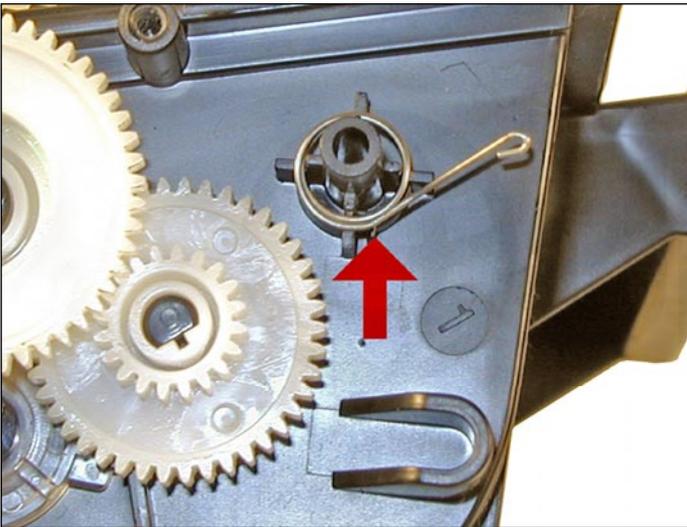
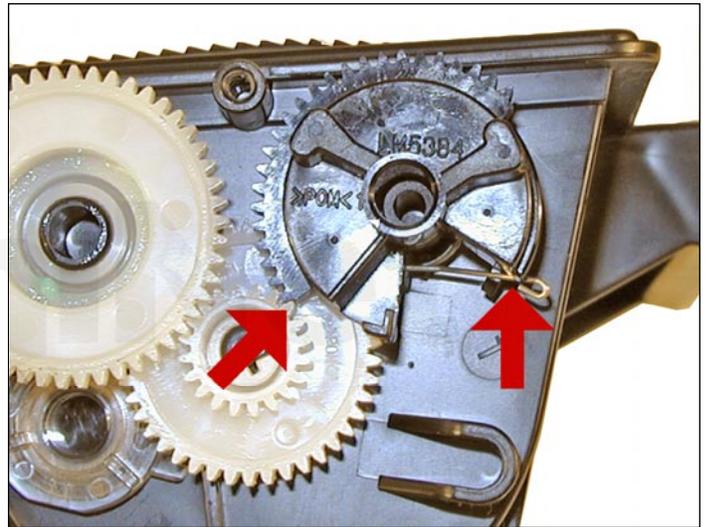
18. Set the reset gear and spring as shown. The straight tail of the spring fits into a notch at the base of the gear shaft.

The teeth of the reset gear should start to mesh with the other gear as shown.

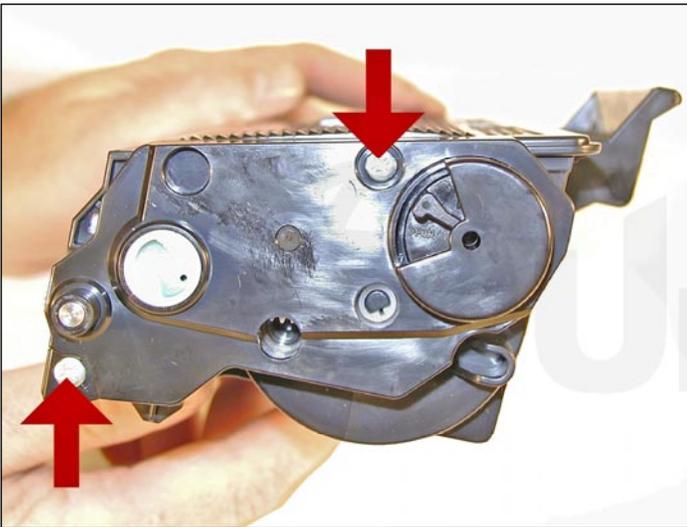
19. Install the gear cover plate, and two screws.

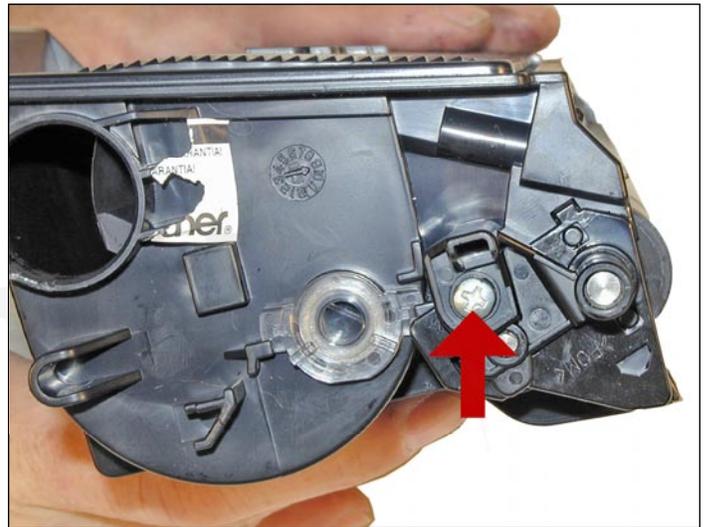
20. Install the drum axle plate on the non gear side and screw.

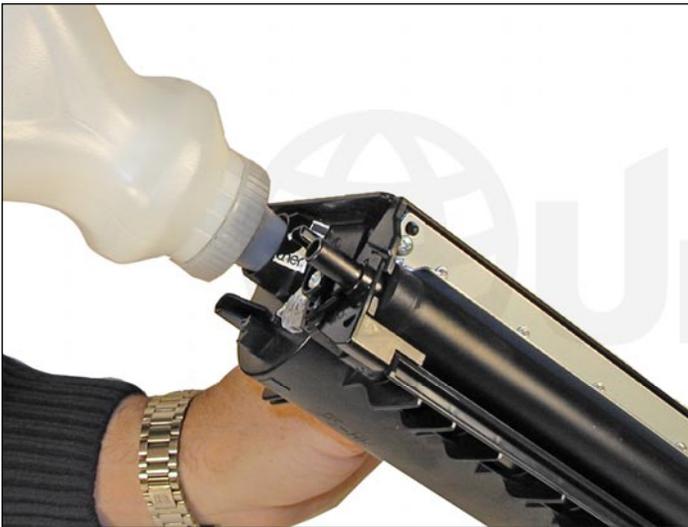
21. Fill the cartridge with replacement toner.

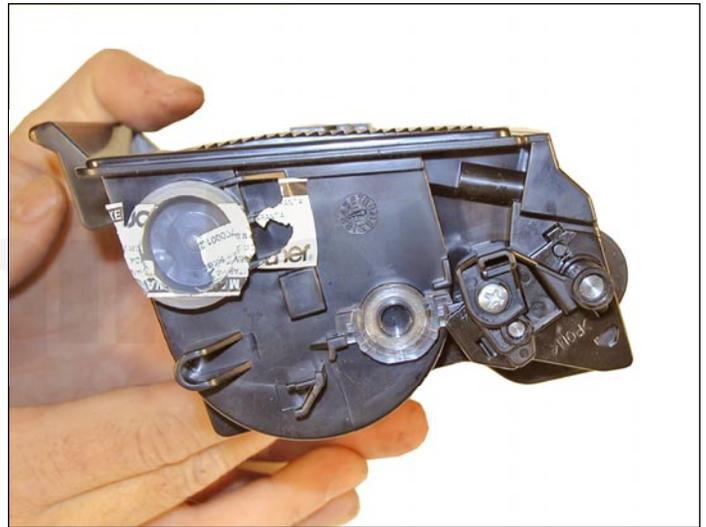
22. Replace the fill plug.

Wipe the cartridge down to remove any remaining toner dust.

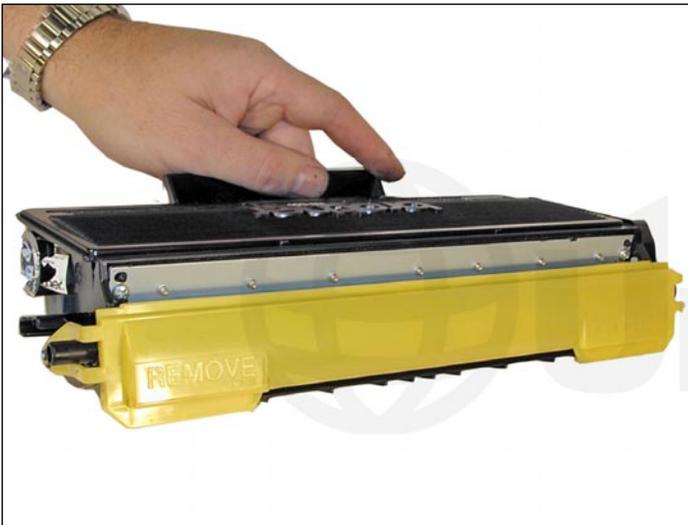
23. Install the developer roller cover.
