BROTHER® TN450 TONER CARTRIDGE

REMANUFACTURING THE BROTHER HL-2240/2270 SERIES TN420/450 TONER CARTRIDGES

By Mike Josiah and the Technical Staff at UniNet

Updated 10/2011

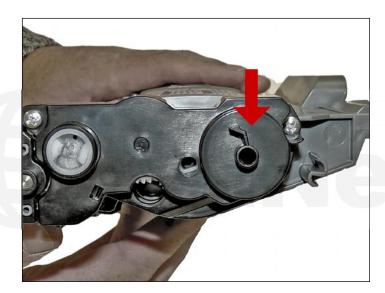
There is a reset gear (pictured here) that resets the printer each time a new toner cartridge is installed.

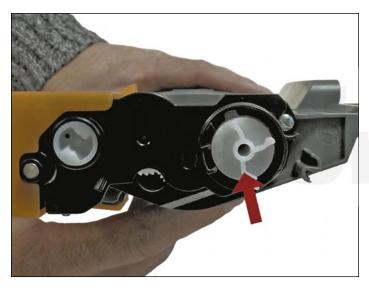
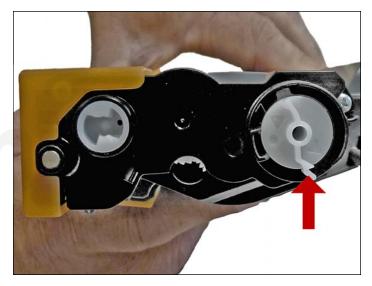
In our machine, the starter cartridge was marked just "TN" and had the reset gear section completely blocked off.

In order to recycle starter cartridges, the proper reset gear and the end cap must be replaced. Both the TN420 and the TN450 cartridges use different reset gears. The TN420 gears have three flags on them, versus two flags for the TN450. That is how the machine knows if there is a standard or high yield cartridge installed. New reset gears and an end cap are available, so that low yield cartridges can be made into high yield, and starter cartridges can be recycled into either one.

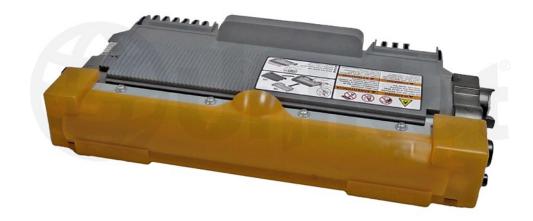
These cartridges also use a completely new developer roller cover, as shown here. An interesting point in the reset process is what happens in addition to the counter being reset. When the printer senses a new toner cartridge, the bias voltage is set to a high voltage. As the cartridge is used, the bias voltage is gradually reduced down. This process is necessary because according to Brother, a new toner cartridge has a tendency to print light. As the cartridge is used, the density increases. To keep the density level even throughout its life, the density bias voltage is reduced accordingly. Each time a new cartridge is installed, the bias voltage is reset to the high voltage point, and the cartridge page count is reset to zero. Since different yields would dictate different decreases in density over time, Brother uses different reset gears. This was also done in other Brother cartridges, but after a time Brother just went with the high yield gear for both cartridges. Time will tell on what they do with these cartridges.

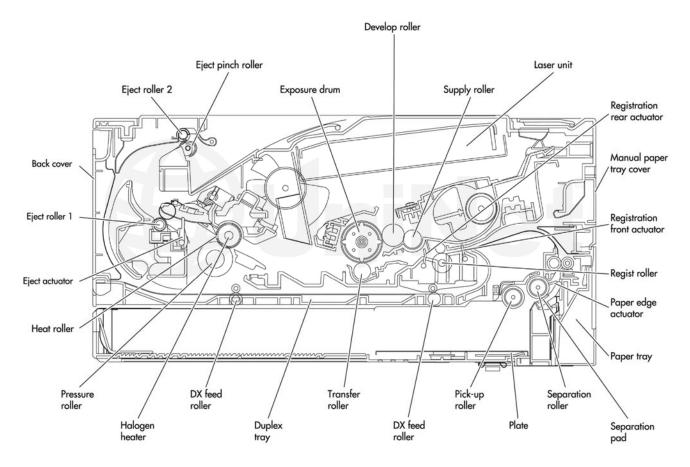
FRONT SIDE

The above diagram shows how the toner and drum cartridges relate (position-wise) to the rest of the printer.

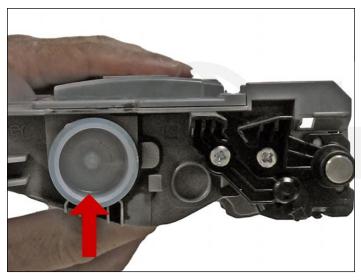
1. Vacuum the exterior of the cartridge. Remove the fill plug from the toner cartridge. Dump the remaining toner and vacuum/blow out the cartridge. Even though on these cartridges the gears are covered, we have found it best to keep one hand over the gear side to protect them.

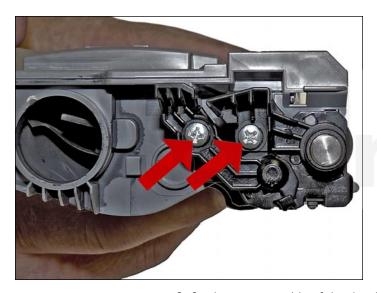
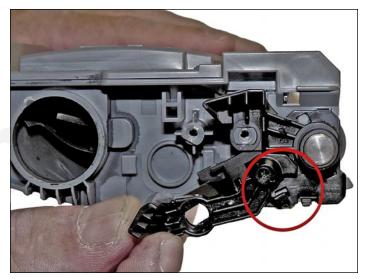
2. On the non-gear side of the developer roller, remove the two screws.

Remove the two plastic arms.

The smaller arm needs to be turned to release the lock.

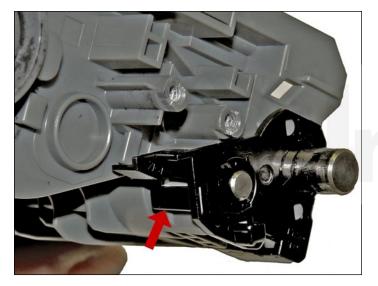
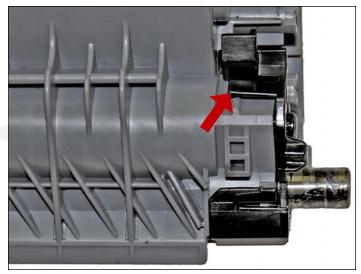
3. Remove the drum axle plate by lifting up on the two tabs as indicated.

Pry the plate off.

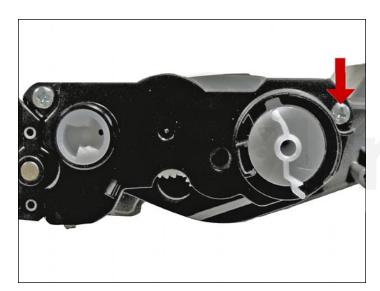
4. On the gear side, remove the two screws and cover-plate.

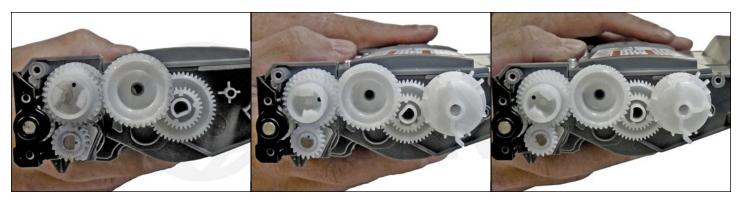
5. The reset gear is spring loaded and must be positioned correctly for the printer to accept a new cartridge. Our printer came with a starter cartridge that did not have a reset gear, and the end cap blocked us from adding a new one in. Starter cartridges will need to have a reset gear and replacement end cap before they can be used. As stated before, the TN420 and TN450 cartridges both have different reset gears. All three types are shown here.

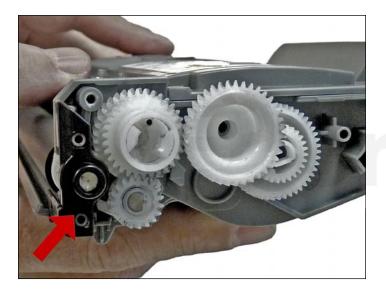
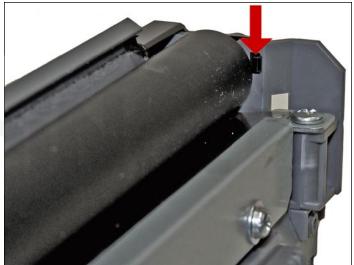
6. Remove the black plastic spacer from the developer roller shaft.

Press in on the back tab to release.

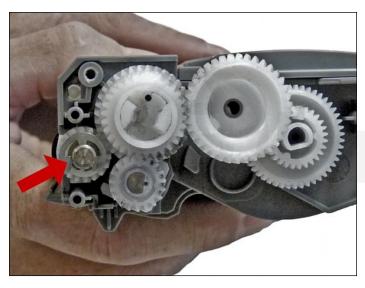
7. Remove the E-Ring.

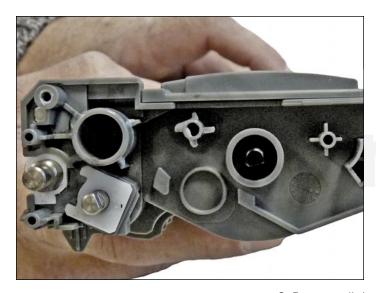
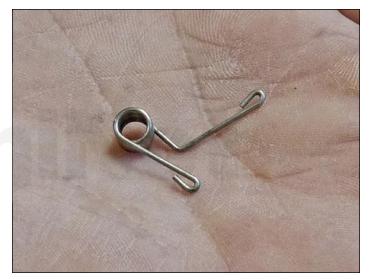
8. Remove all the remaining gears.

Do not lose the reset gear spring!

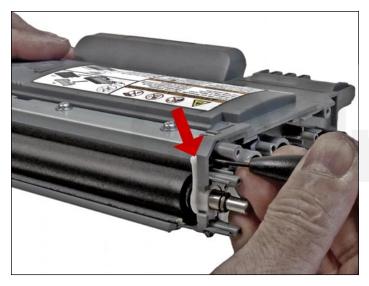
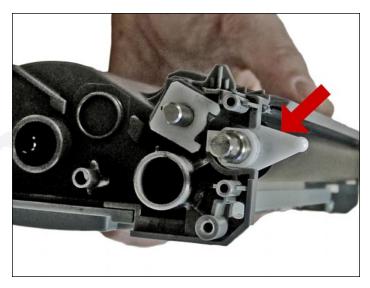
9. On the gear side of the developer roller, press in on the locking tab, and rotate the developer roller lock up.

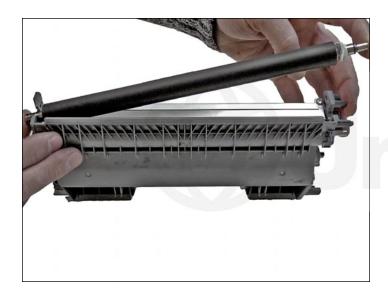
10. Remove the developer roller.

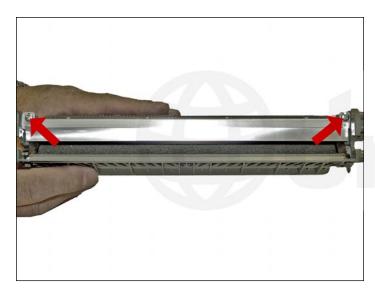
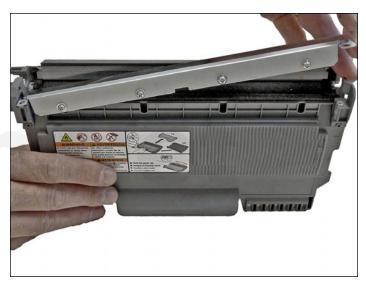
11. Remove the two doctor blade screws and the doctor blade.

Unlike previous TN cartridges, the doctor blade is not physically attached to the seals, so it can be removed for cleaning.

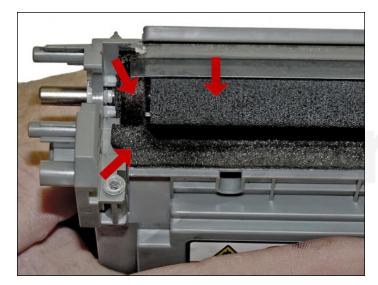
12. Completely remove all remaining toner from the toner hopper, foam feed roller, and the doctor blade foam seals.

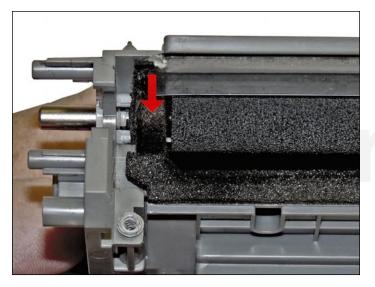
13. Inspect the magnetic roller felts. If they are compressed (shiny), rough them up with a small screwdriver.

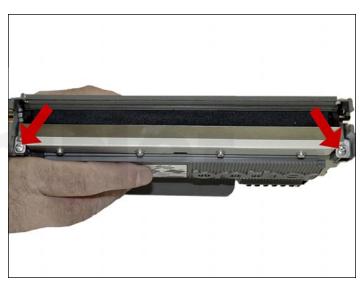
14. Carefully wipe the doctor blade down with a lint-free cloth. Be very careful not to bend or damage the blade in any way. Install the blade and two screws.

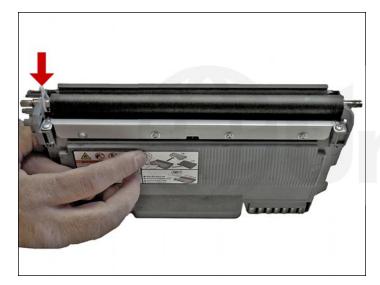
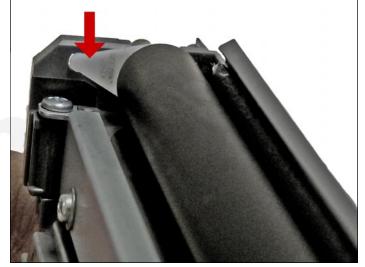
15. Clean the developer roller with a lint-free cloth and a dedicated developer roller cleaner for Brother rollers. Do not use any chemicals other than a dedicated cleaner for Brother rollers to clean the roller. Re-install the developer roller long-shaft side to the gear side, with the white lock pointing up. Turn the lock towards the doctor blade until it locks in place.

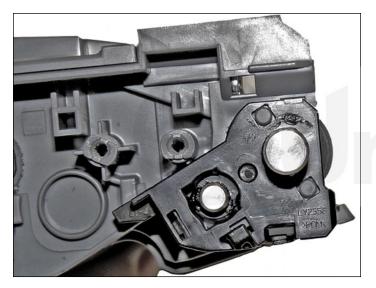
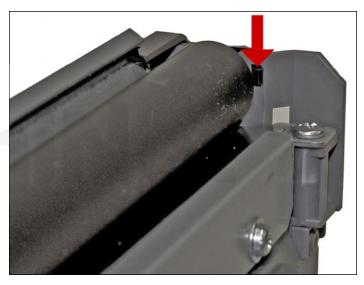
16. Install the non-gear side axle plate.

Make sure the tabs lock in place.

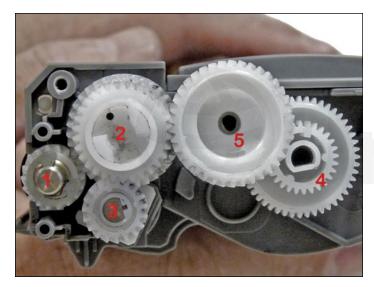
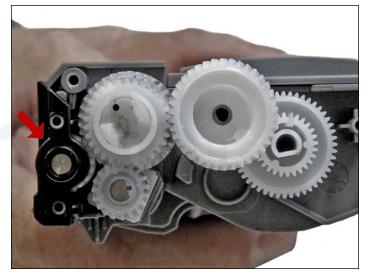
17. Clean the gears, making sure that they have no toner on them. This is a good time to also check the gear shafts to make sure there is enough grease. If the shafts appear dry, or the grease is contaminated with toner, clean the shaft and inside of the gear. Replace the grease with white lithium grease. Install the developer roller gear, E-ring, black axle spacer, and the rest of the gears in the order shown. Make sure all the gears are meshing properly.

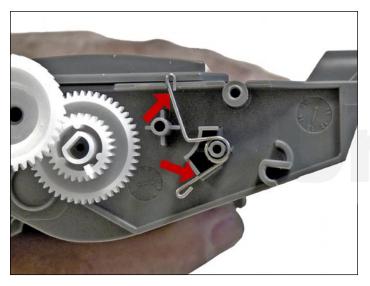
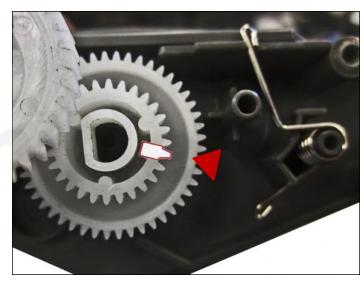
18. Set the reset gear spring as shown, ensure the actuator gear is in the following position

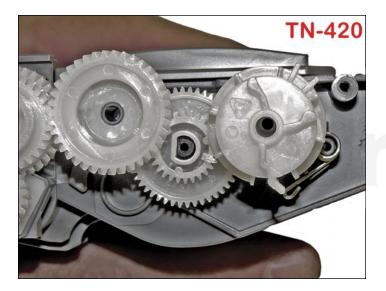
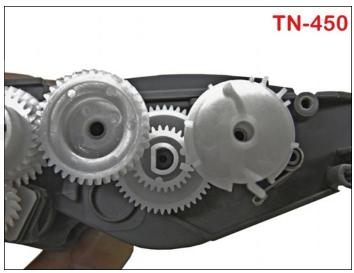
19. Depending on the cartridge you have, set the reset gears as shown:

TN420 (left photo)

TN450 (right photo)

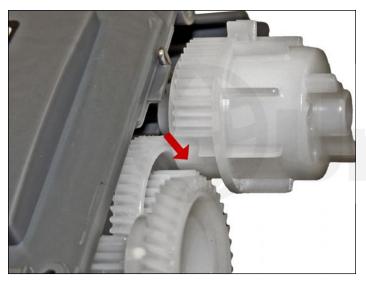
Note that the gear teeth are not meshed when set, which is how it should be. The gear is spring loaded and will turn when driven by the printer.

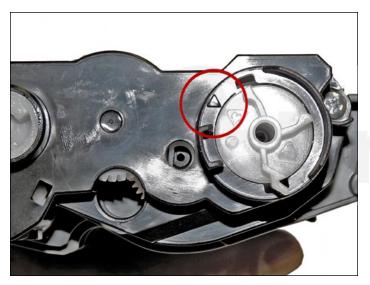
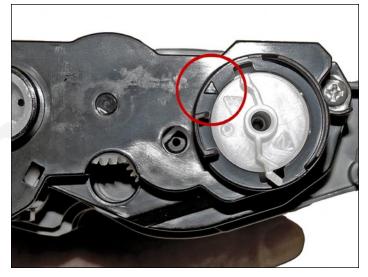
20. Install the gear cover plate, and two screws as shown for the TN420 (left image), or for the TN450 (right image).

Make sure the black arrow on the cover is aligned with the white arrow marked #3 on the TN420 gear, or #1 on the TN450 gear.

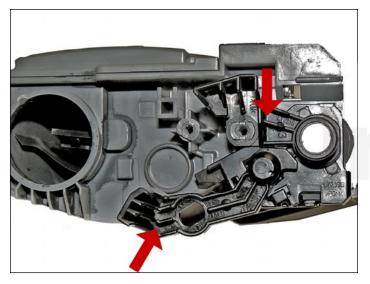
21. On the non-gear side, install the two plastic arms and screws.

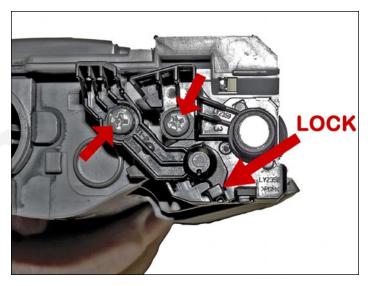
The smaller arm is installed last and has to be turned from the bottom up, so that the lock engages.

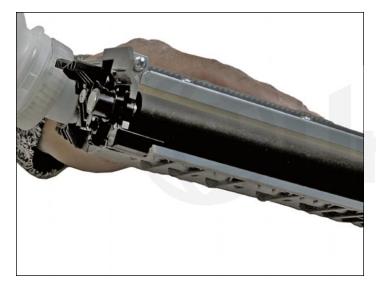
22. Fill the cartridge with the proper gram load of black toner for use in Brother TN420/450 (low or high yield).

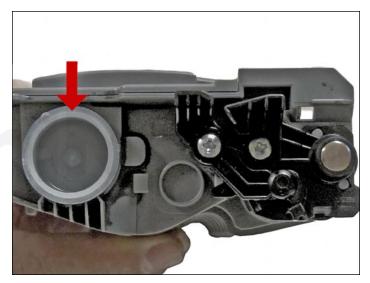
23. Replace the fill plug.

Wipe the cartridge down to remove any remaining toner dust.

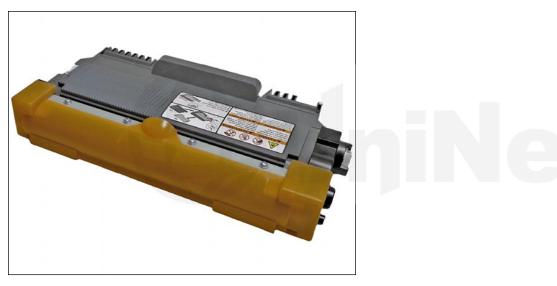
24. Install the developer roller cover.

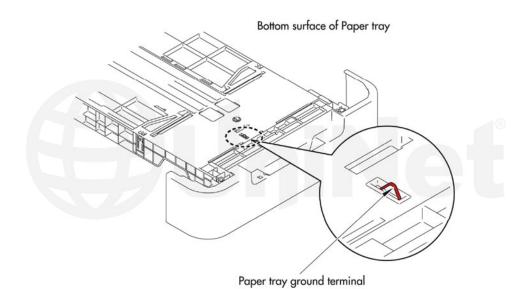
NOTE: If you are experiencing horizontal black streaks, and changing cartridges does not help, look in the bottom of the paper tray. There is a small metal ground terminal. If it gets bent or dirty, it can cause this.
