LEXMARK™ E120

TONER & DRUM CARTRIDGE REMANUFACTURING INSTRUCTIONS

REMANUFACTURING THE LEXMARK E120 TONER & DRUM CARTRIDGE

By Mike Josiah and the Technical Staff at UniNet

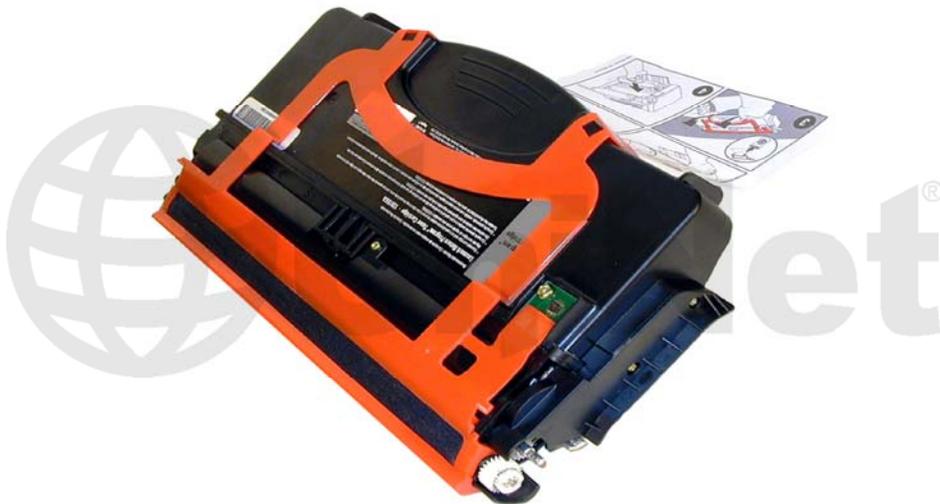
CARTRIDGE COVER

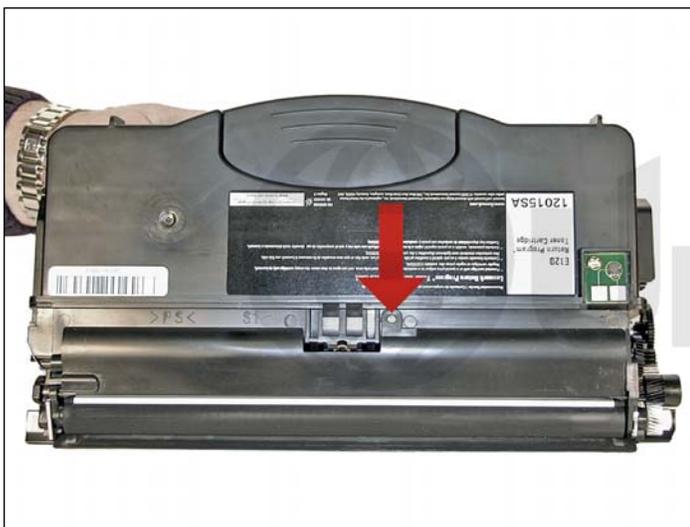
3. Remove the center screw on the developer roller cover.

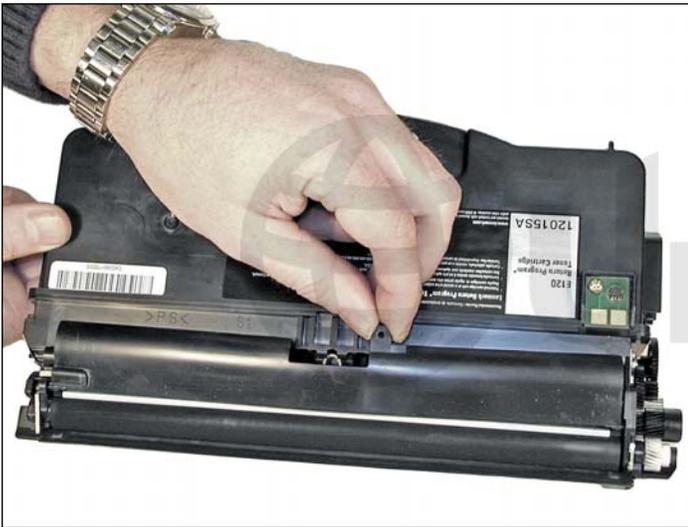
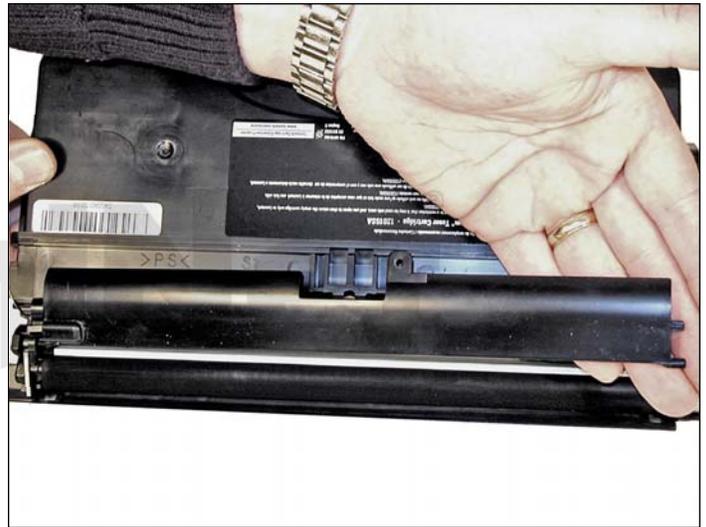
4. Lift up the developer roller cover from the center, and remove.

Be careful not to damage the plastic pins on the cover.

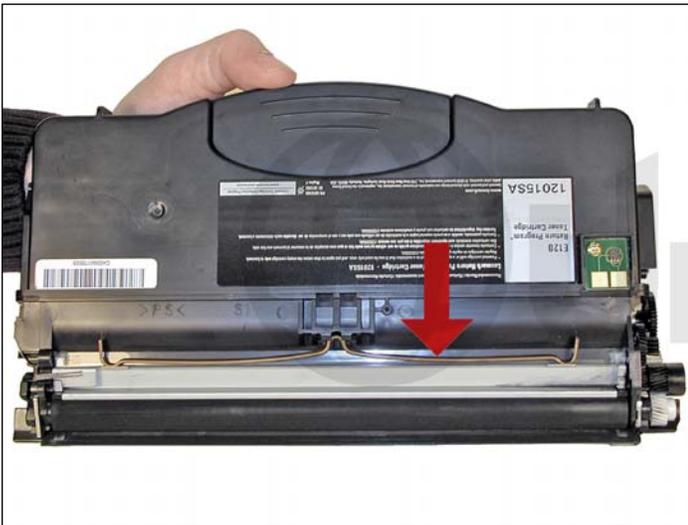
5. Remove the doctor blade spring.

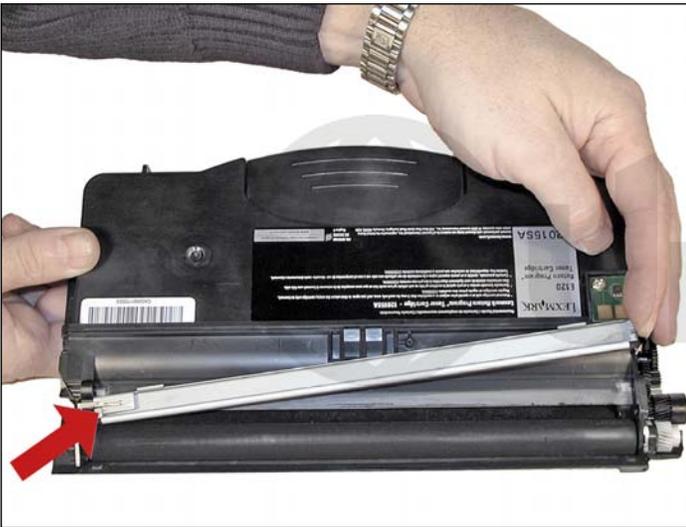
6. The doctor blade is now loose.

Carefully lift it out, watching the contact spring on the right side.

Also, be careful not to damage the retaining blade that is located under the doctor blade.

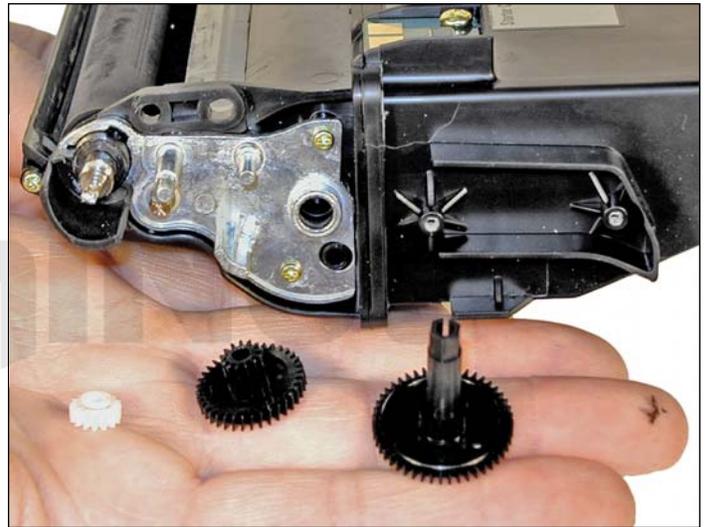
10. Remove all the gears.

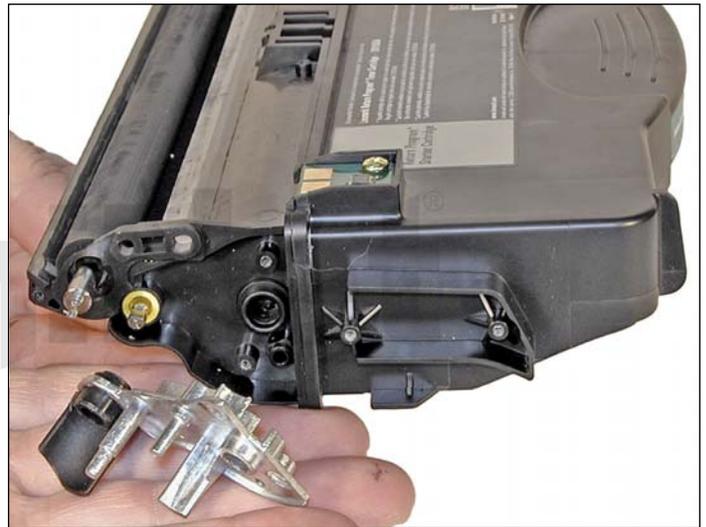
11. Remove the three screws and gear alignment plate.

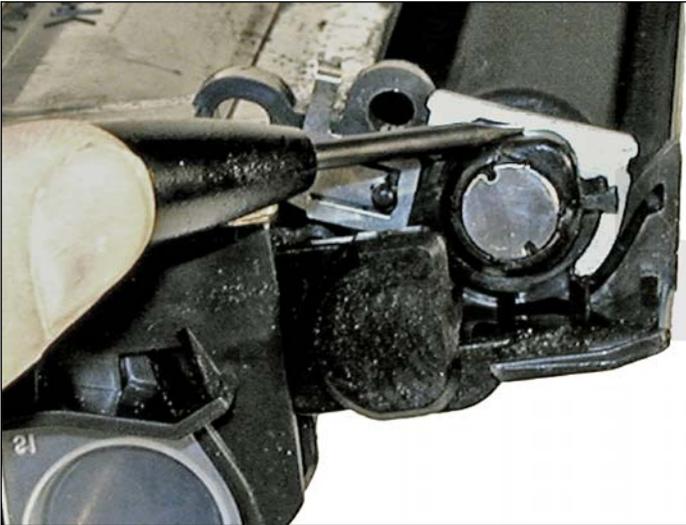
12. With a small flat head jeweler's screwdriver, pry off the metal lock from the developer roller bushing.

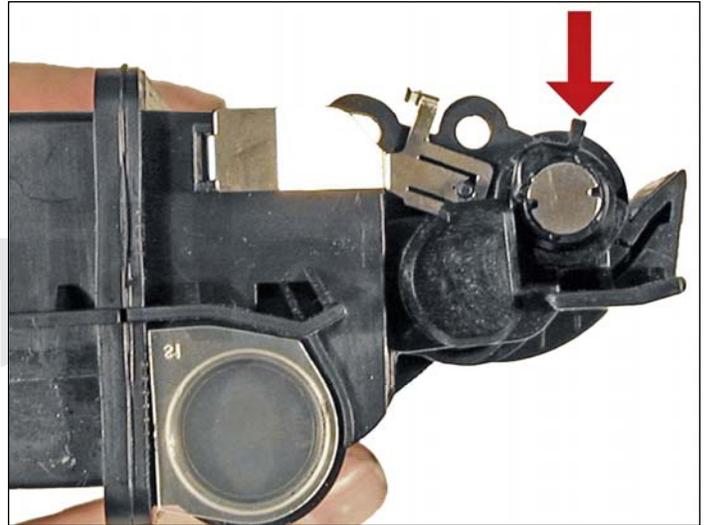
13. Turn the developer roller bushing so the plastic tab is facing up.

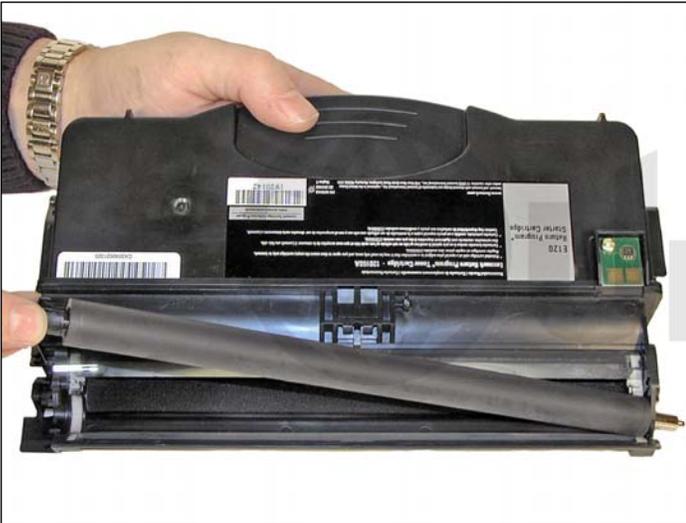
14. Lift the developer roller out of the cartridge.

The bushing will come off with the roller.

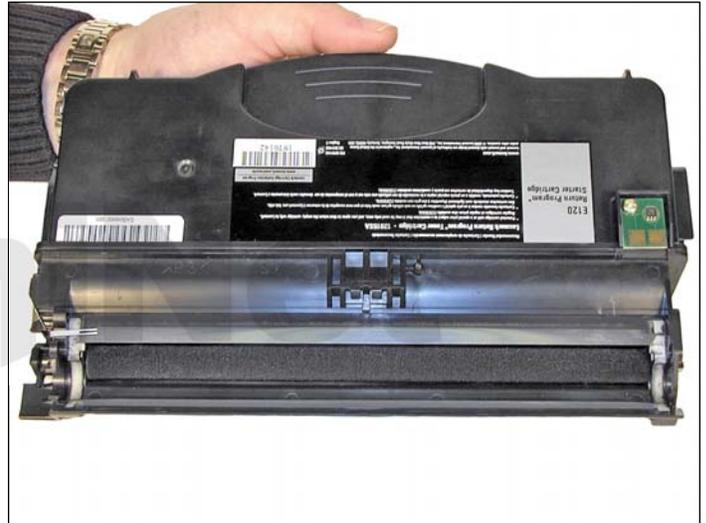
15. Clean out any remaining toner from the hopper. Make sure the developer roller retaining blade does not get damaged!

Wipe the developer roller down with a clean lint free cloth. Testing is ongoing, but for now, do not use any chemicals to clean it.

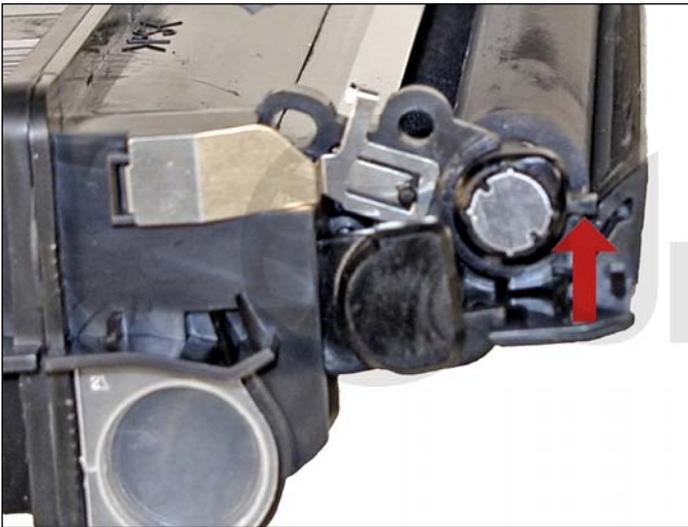
16. Reinstall the developer roller. Spin the plastic bushing so it is locked in place.

Install the metal locking bar, note that the left side fits into the small notch, and the right side is flush with the hub.

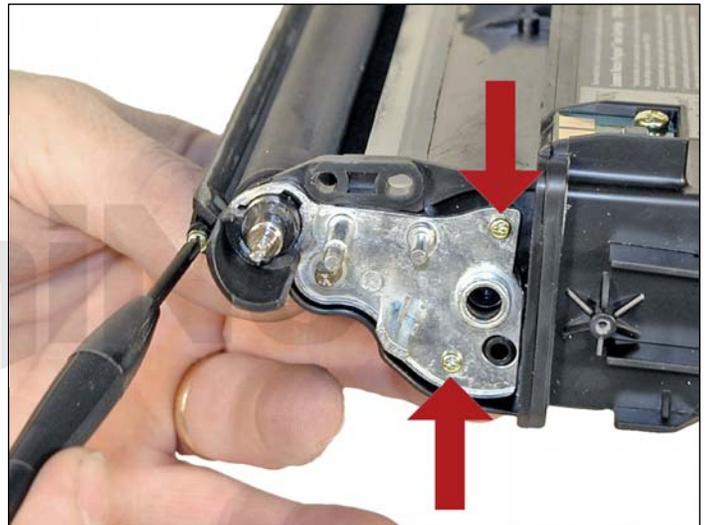
18. Install the gear axle plate and three screws.

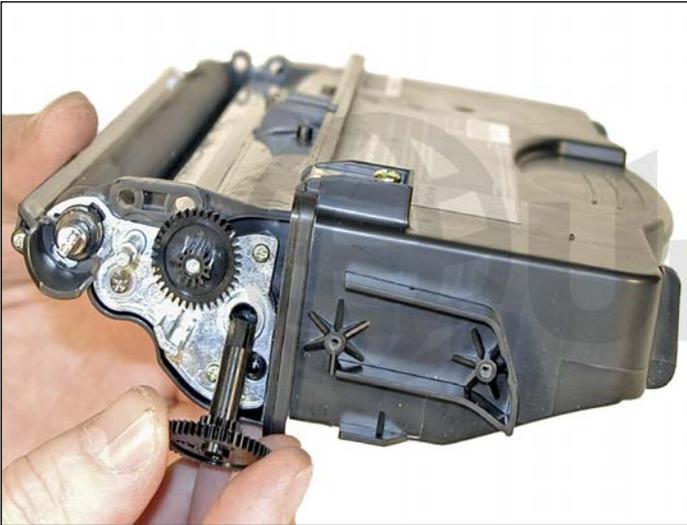
19. Install the gears. The large gear with the long shaft fits onto the toner agitator bar inside the hopper. Spin it a few times and listen to make sure it is engaged properly. On the large drive gear, make sure the flat washer is in place, and install a new star lock washer. Make sure the lock washer is pressed down fully against the base of the gear.

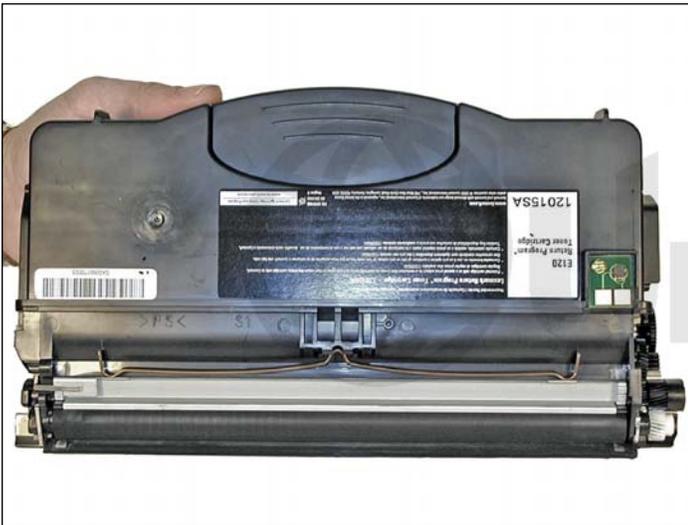
22. Install the doctor blade spring.

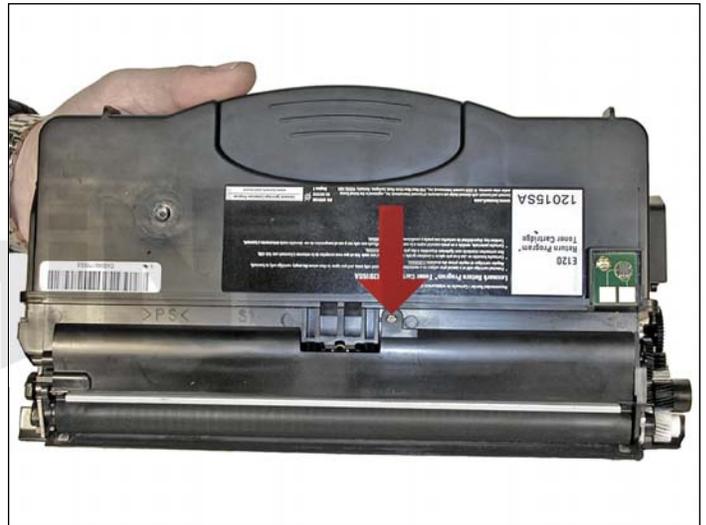
23. Install the developer roller cover and screw.

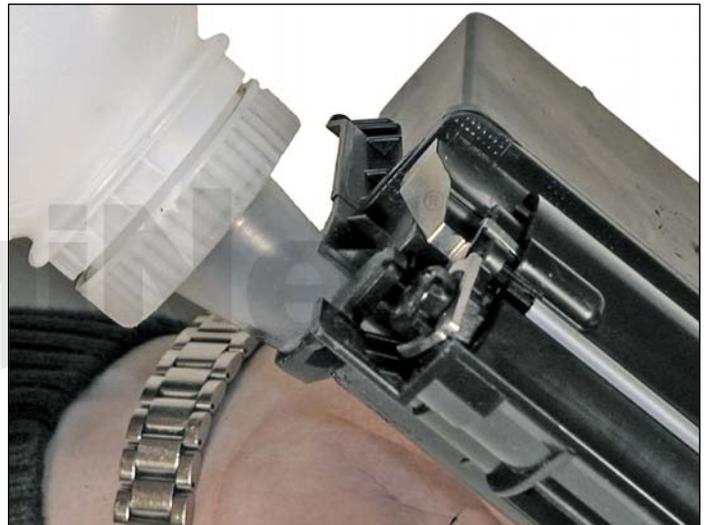
25. Fill hopper with toner for use in Lexmark E120.

Replace the fill plug.

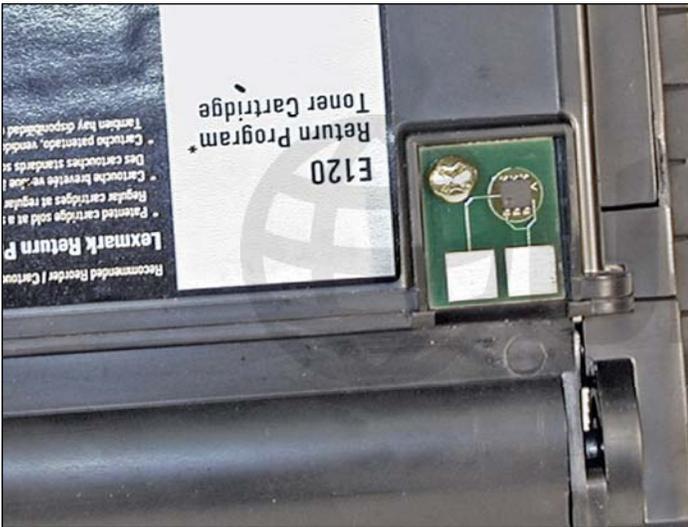
26. Replace the chip.

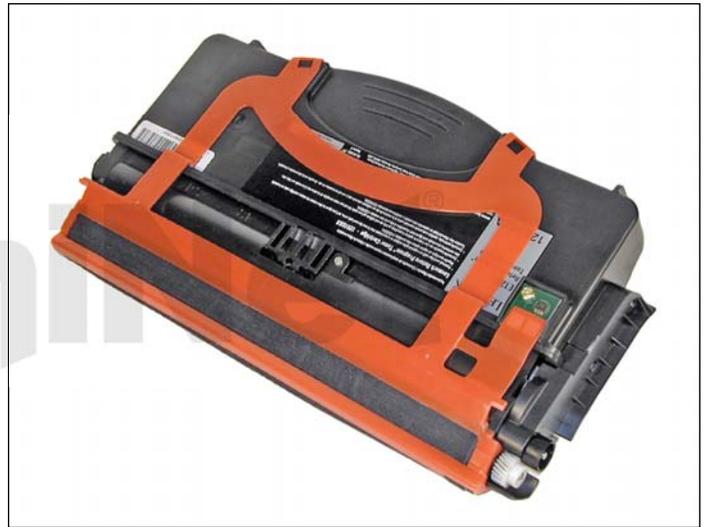
27. If the cartridge cover is available, wrap the cartridge as indicated. This cover helps protect the developer roller from damage. Aftermarket covers are in development.

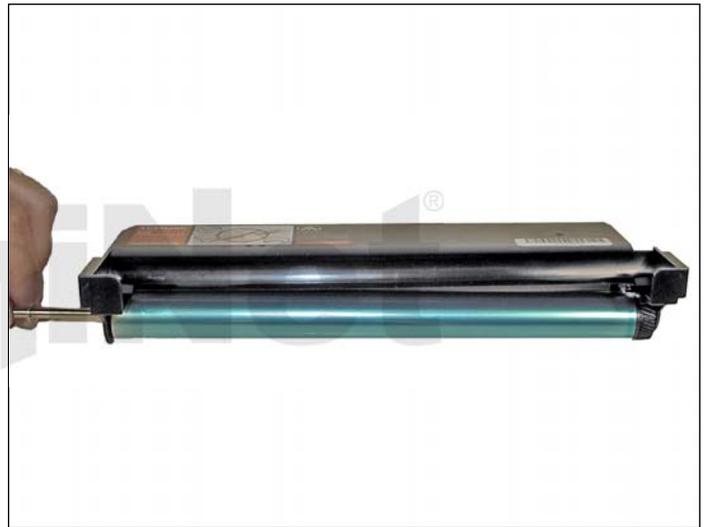
29. Slide the drum axle out from the drum.

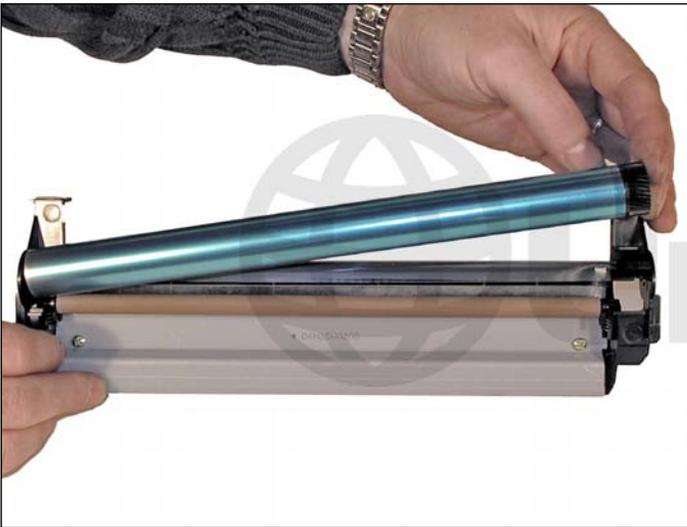
30. Remove the drum.

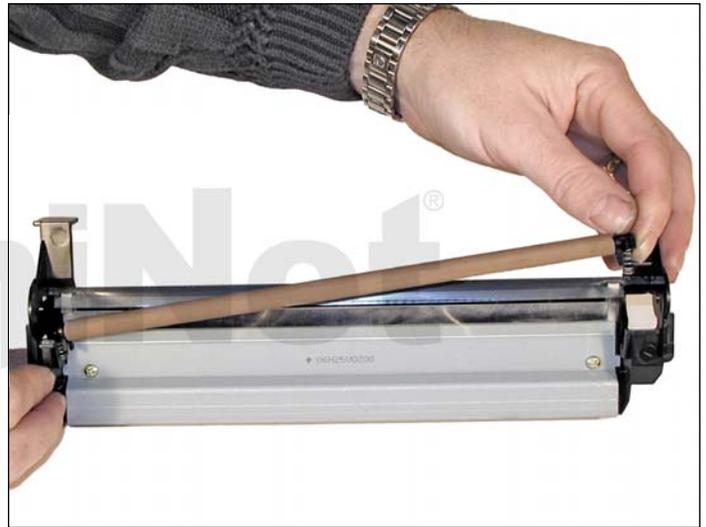
31. From the right (gear) side, remove the PCR assembly (the spring loaded holder may come with it).

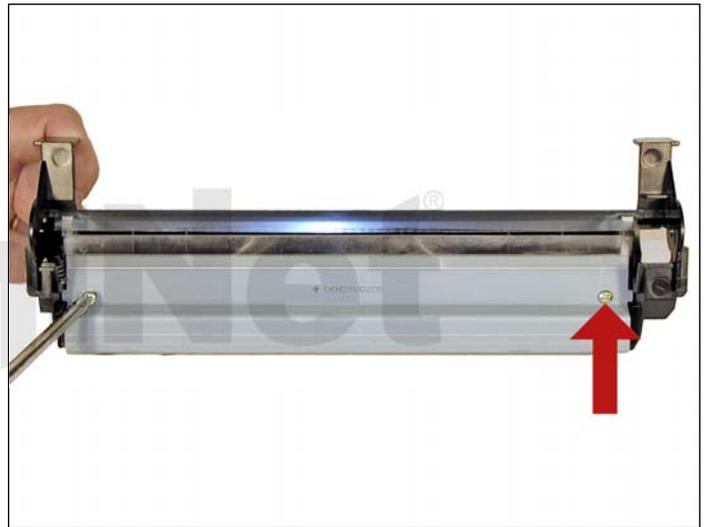
33. Clean and coat the edge of the wiper blade with your preferred lubricant. Install the blade and two screws.

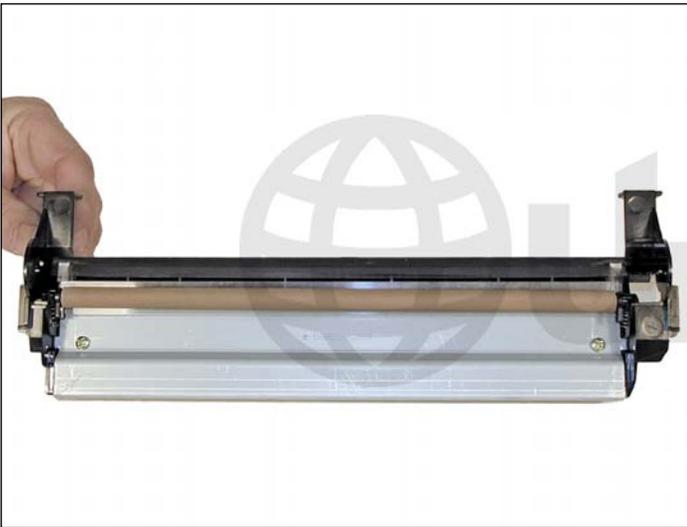
34. Clean the PCR and install. Make sure the black spacers are orientated towards the back of the wiper blade as shown.

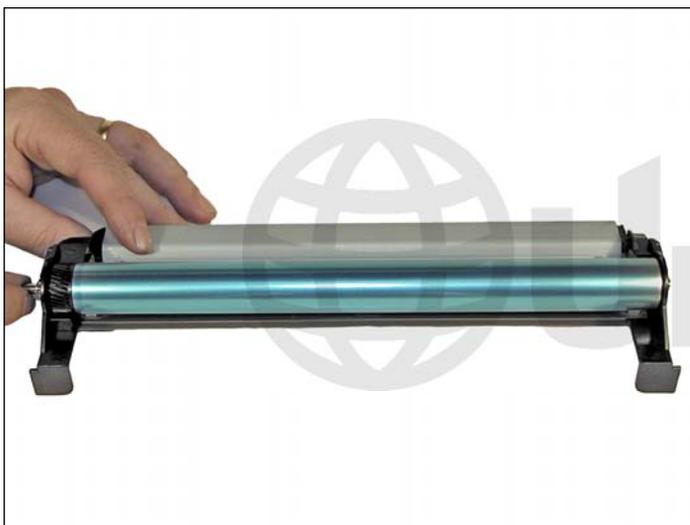
36. Install the drum axle shaft from the gear side of the drum.

Install the E-ring.
